# Manhole Inspection Summary

Manhole # S21CC\_032MH

Insp Date: **10/24/07 9:42 AM**

**Location** Address: **1112 ALLEY-MCKEAN-FULTON**

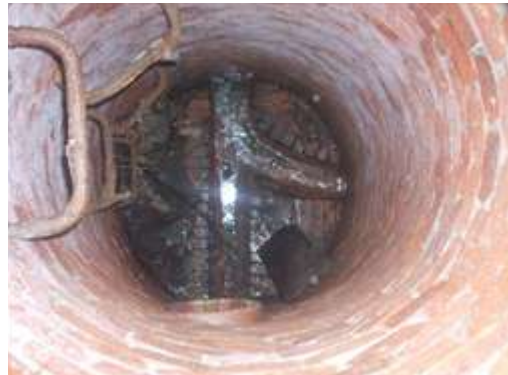
Top View

DEBRIS

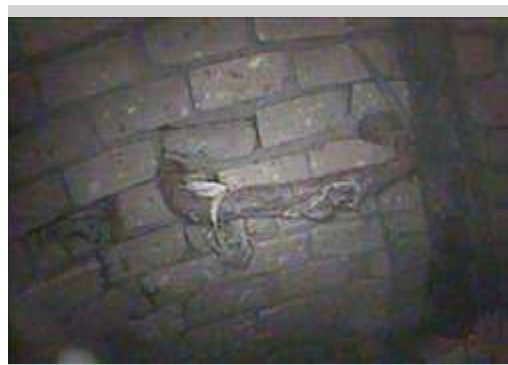
Defect 2

**Surcharge** ☒ **Evidence Of Surcharge** Depth: **5** (ft.) ☐ Active Surcharge Present

SURCHARGE EVIDENCE

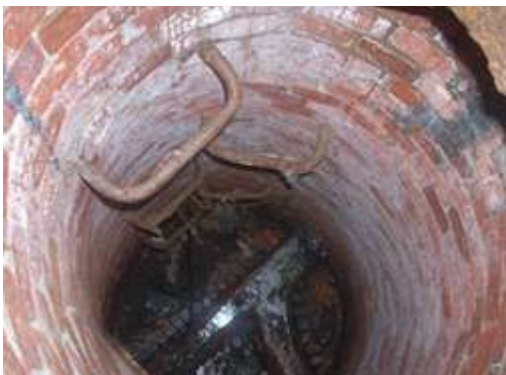
Defect 1

**Steps** Count: **7** Missing: **0** ☒ **Corroded**

CORRODED STEPS

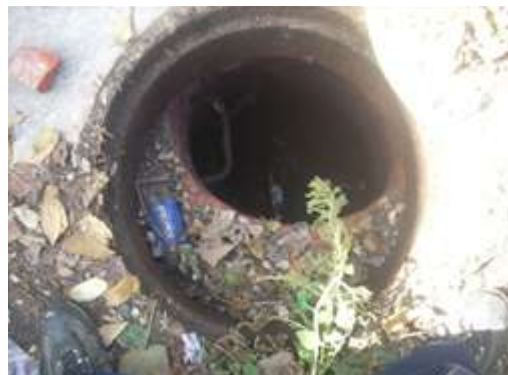
Defect 3

Comments **MAJOR FRAME OFFSET**

**Frame** Offset: **8** (in.) Condition: ☒ Sound ☐ Cracked ☐ Leaks

MAJOR FRAME OFFSET

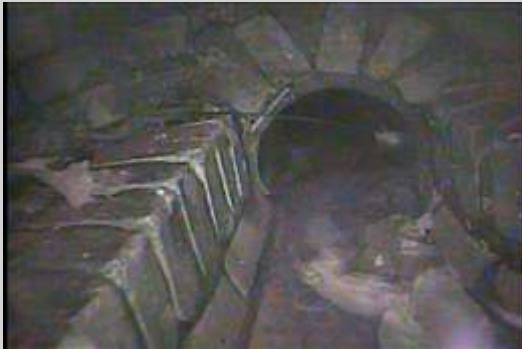
12 O'Clock Outflow

Pipe Height: **8.4** (in.) Rod and Bar (Angled)  
Pipe Material: **Clay** ☐ Pipe Lined  
Invert Depth: **10.85** (ft.) Flow Characteristics: **Slow**  
Deposits: ☐ None ☐ Mud ☒ **Gravy** ☐ Debris ☐ Grease  
Silt Depth: **2** (in.) Deposits Extent: **Light**  
Infiltration: **None** Pipe Seal Cond: **Sound**

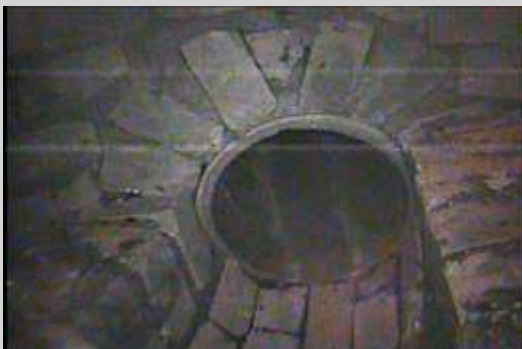
3 O'Clock Inflow

Pipe Height: **8.4** (in.) Rod and Bar (Angled)  
Pipe Material: **Clay** ☐ Pipe Lined  
Invert Depth: **10.70** (ft.) Flow Characteristics: **Slow**  
Deposits: ☒ None ☐ Mud ☐ **Gravy** ☐ Debris ☐ Grease  
Silt Depth: (in.) Deposits Extent:  
Infiltration: **None** Pipe Seal Cond: **Sound**

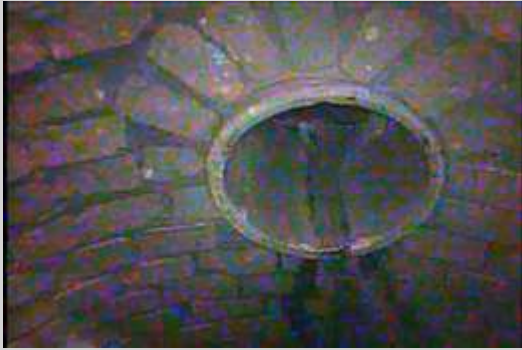
6 O'Clock Inflow

SURCHARGE EVIDENCE

Deposits: ☐ None ☐ Mud ☒ **Sludge** ☒ **Debris** ☐ Grease

Silt Depth: **8** (in.) Deposits Extent: **Heavy**

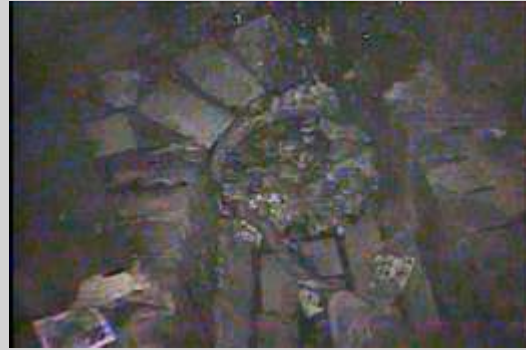
SURCHARGE EVIDENCE
